2022 - 2023 IAQ Walkthrough

Jordan Public Schools Jordan Elementary

Walkthrough Date & Time:
Thursday, March 24, 2022
9:00 AM to 11:00 AM

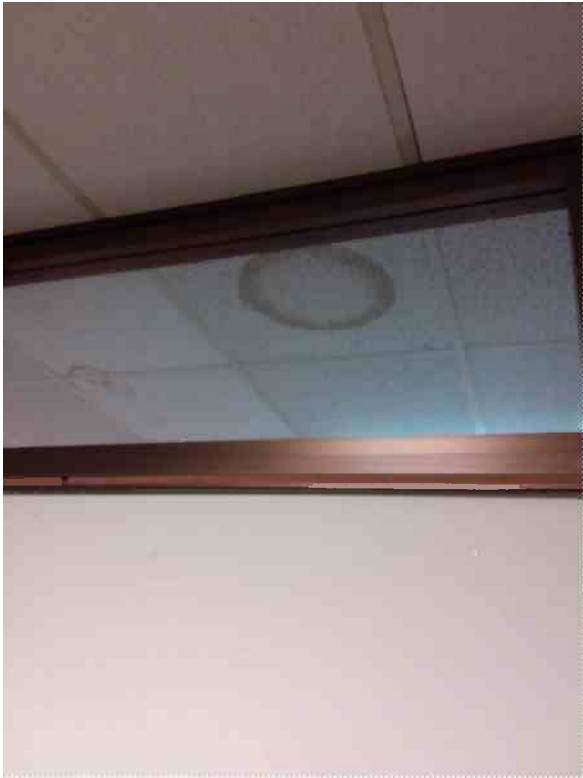
Stained Ceiling Tiles

- 28

Stained ceiling tiles were found in the room(s) shown below. The impacted ceiling tiles should be removed and replaced, and the cause of the moisture repaired.
